Cover I : wooden church in Boz village  
Cover II : wooden church in Târnavița village;  
interior of the wooden church in Crivina de Sus village

Raluca Munteanu

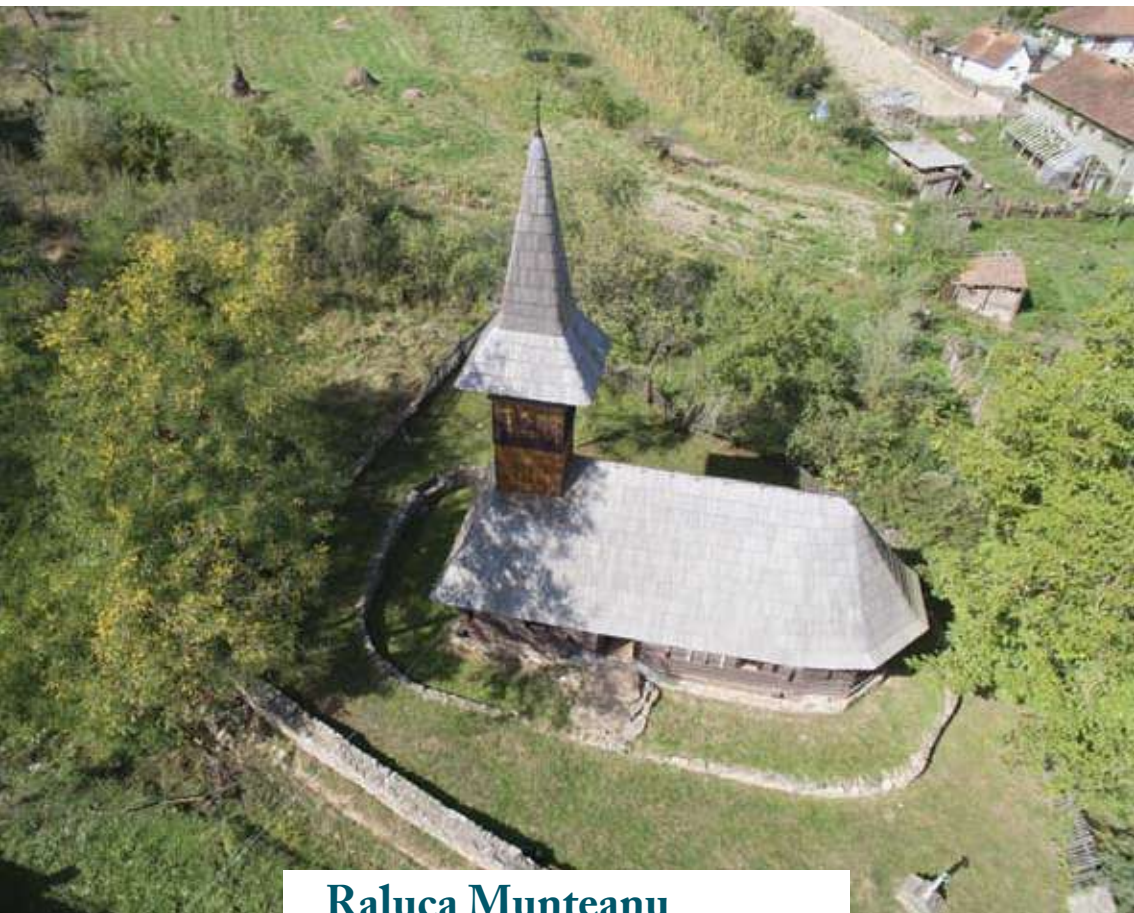
The Romanian National Trust  
Pro Patrimonio Foundation

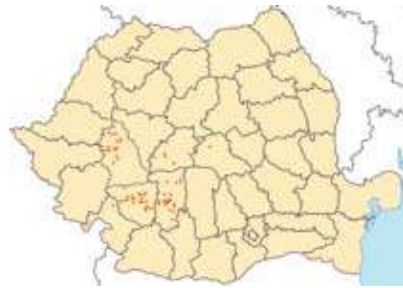
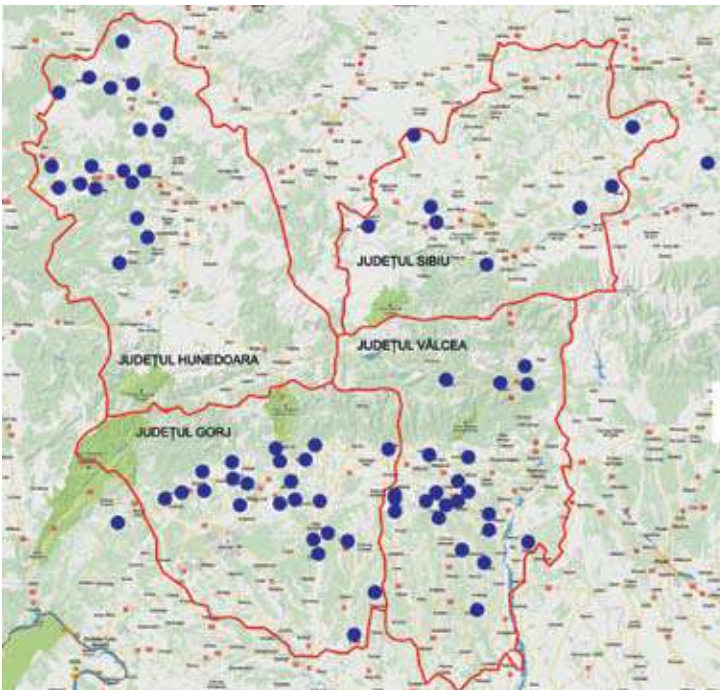
The program *60 wooden churches* monitors the churches in north Oltenia and south Transylvania (Vâlcea, Gorj, Sibiu and Hunedoara counties).

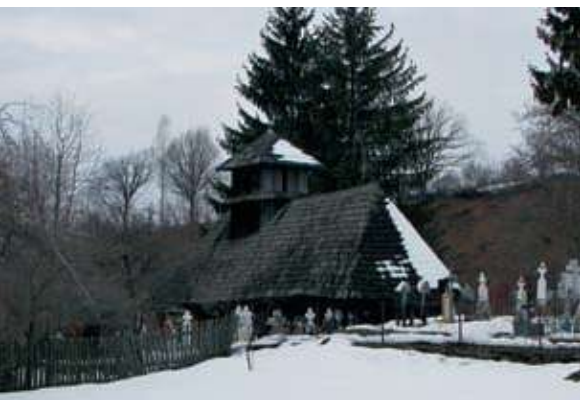
Church in Mlăceni village, Vâlcea county  
(photo from 2014, before restoration)

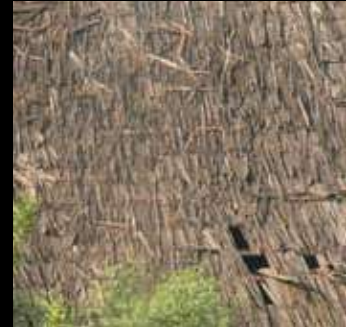
Degraded roofing with wooden shingles

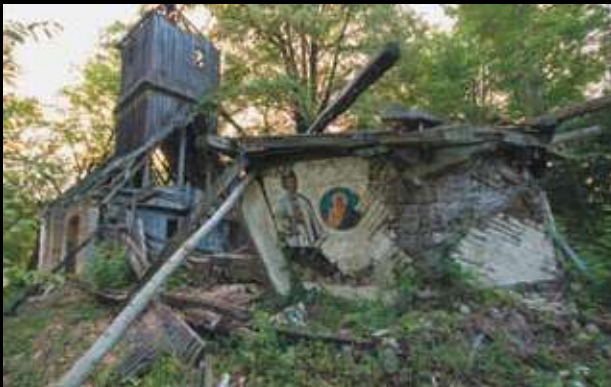
Wooden church in Budurăști, Vâlcea county (photo 2014)

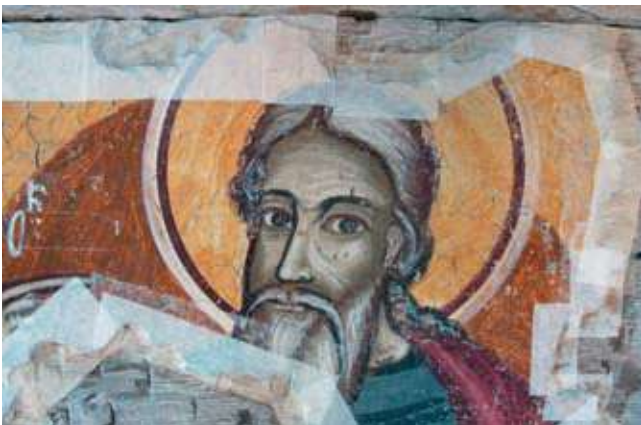
Exterior fresco detail from wooden church in Urși village, Vâlcea county

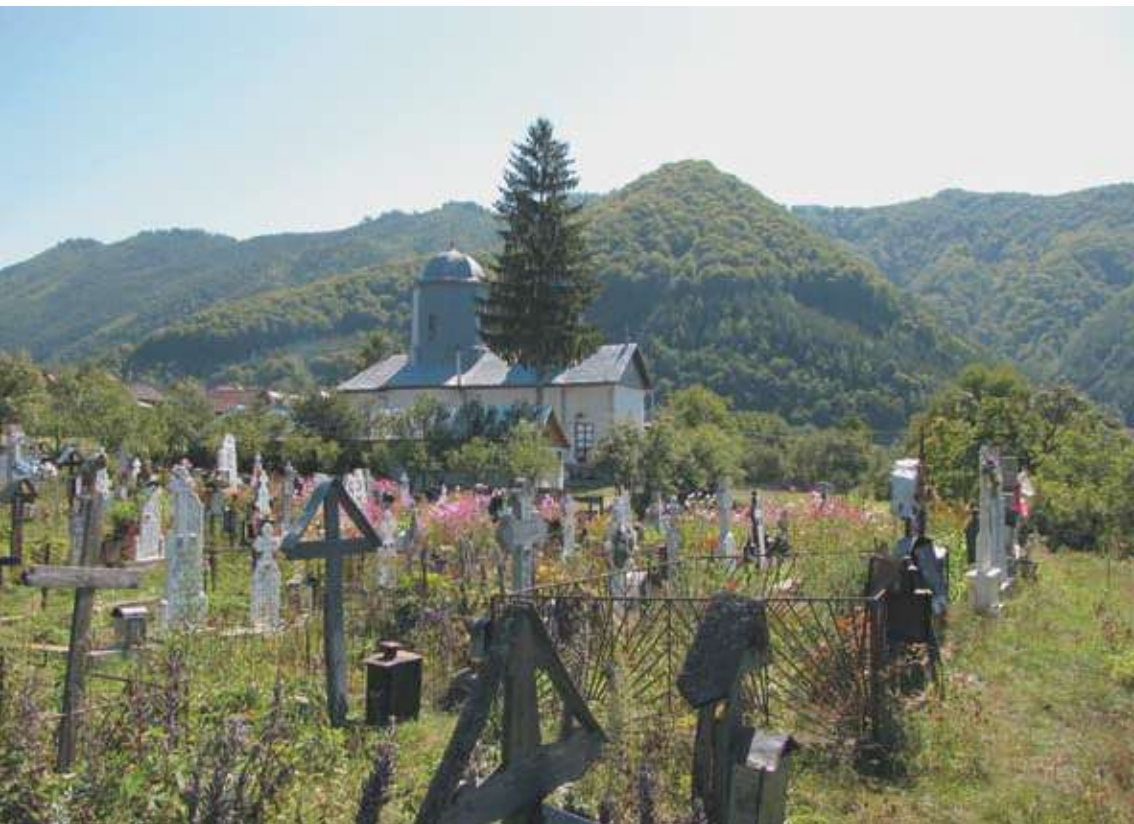
Church and cemetery in Mlăceni village, Vâlcea county

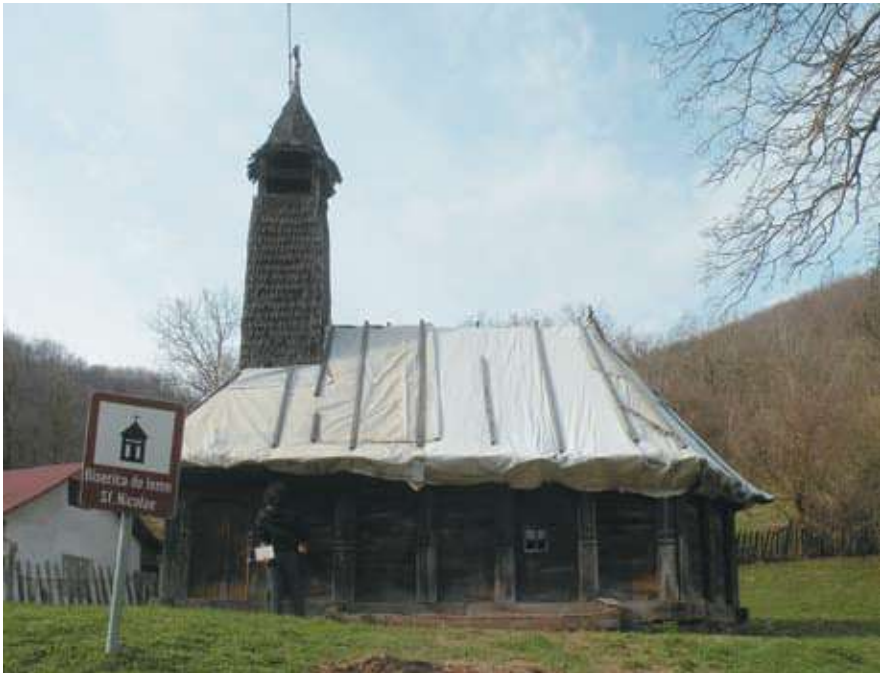
Wooden church in Vălari village, Hunedoara county

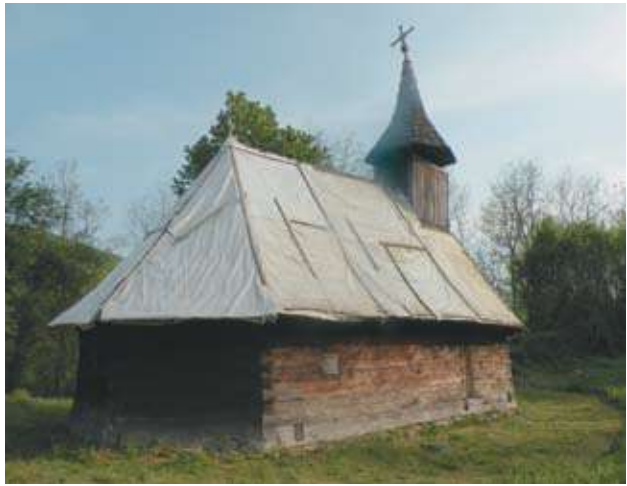
Wooden church in Dumbrăvița, Hunedoara county

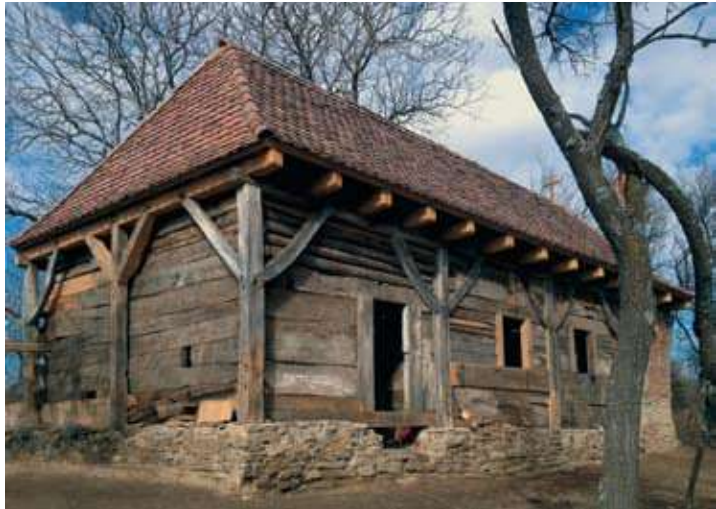
Wooden church in Grânari, Braşov county (photo 2014)

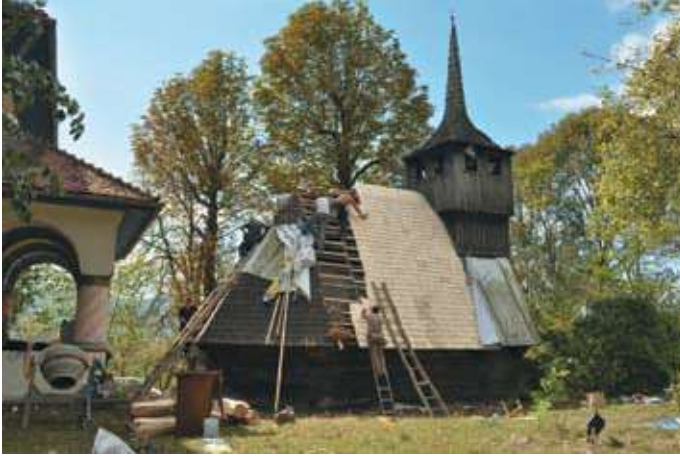
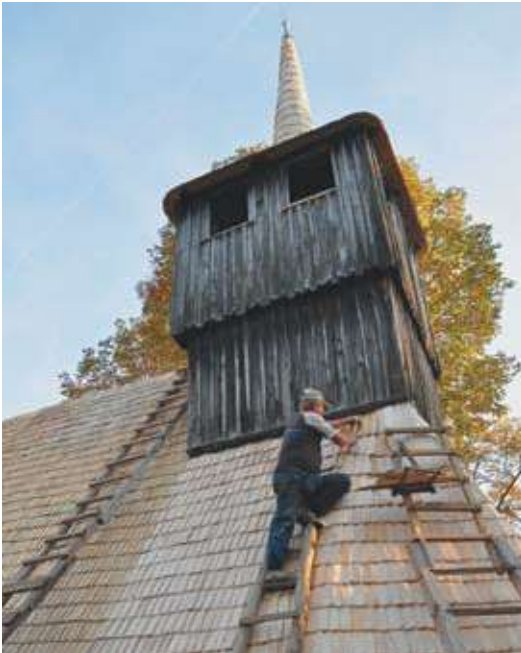
Repair work on church wooden shingles in Tărnăvița, Hunedoara county (photo 2012)

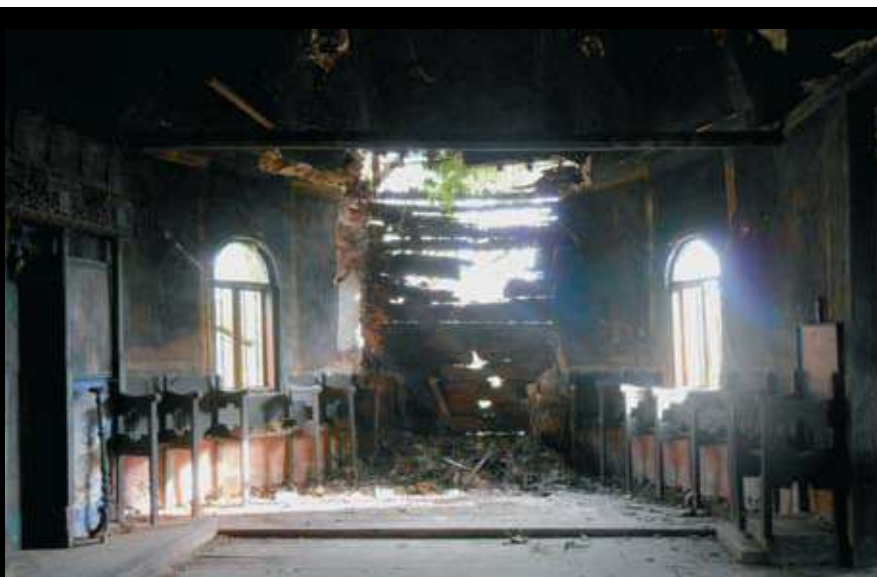
Serious degradation of the log wall caused by rain water infiltrated through the deteriorated roof.

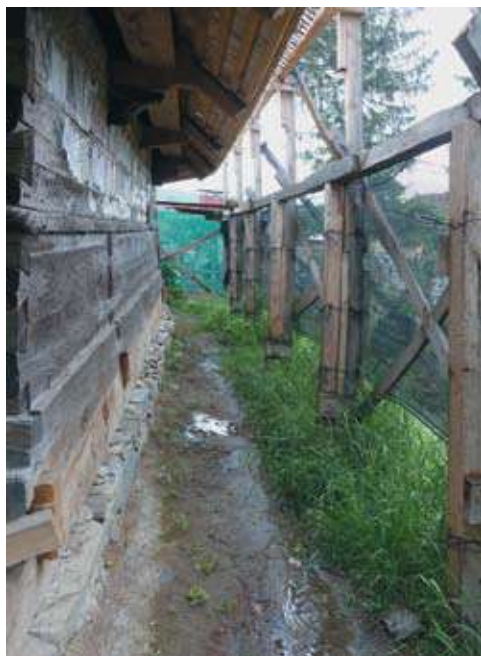
The surrounding pathway is permeable (earth) with an outer gradient that discharges rain water.

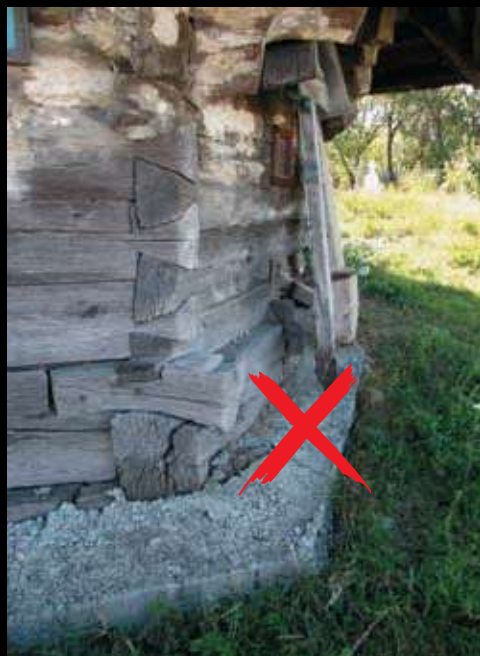
Around the church a cement layer was added that retains humidity and caused the bottom logs to rot.

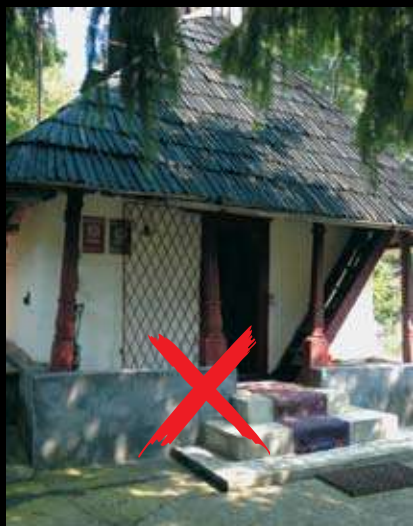
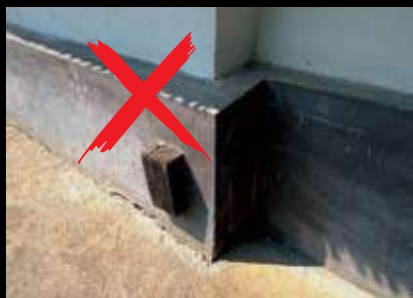
The stone base has been covered in concrete all along the church outline and will deteriorate the wood.

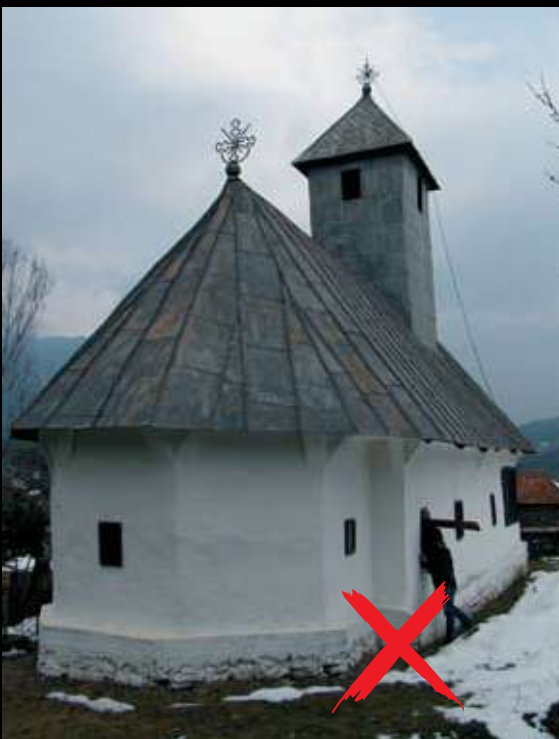
A concrete belt covering the bottom logs was placed over the stone base. This intervention is not appropriate because it will degrade the wood by rooting and weaken the structure.

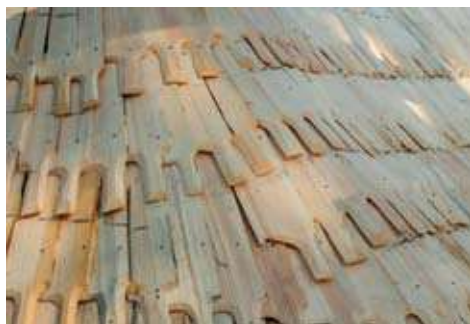
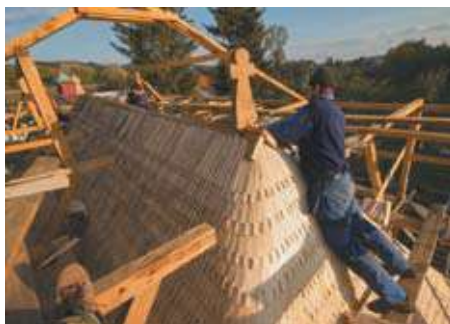
Details of new roofing shingles

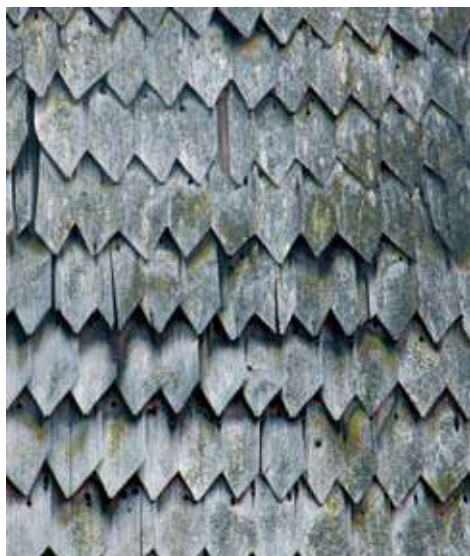
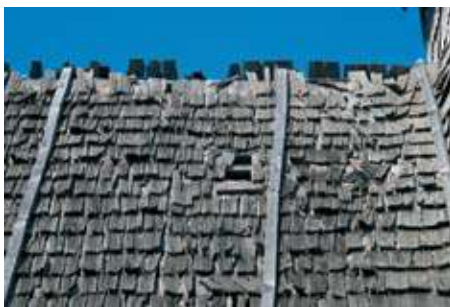
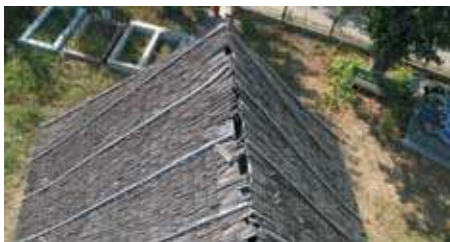
Details of shingles degraded over time

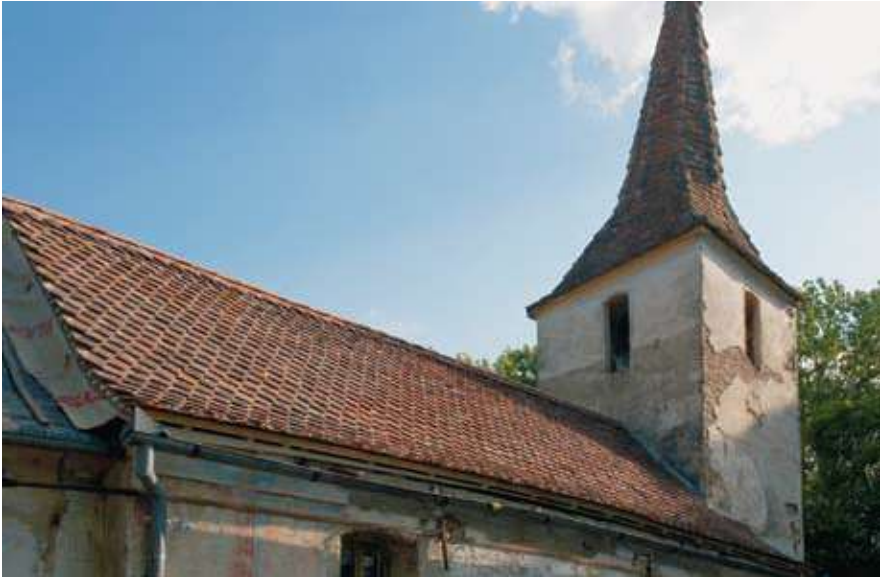
*Handmade ceramic tiles  
specific to Sibiu county*

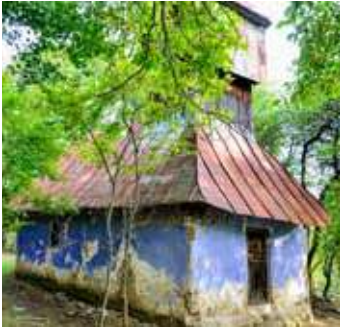
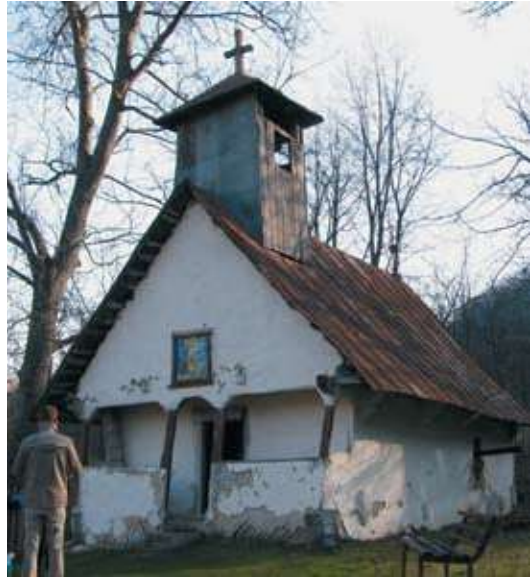
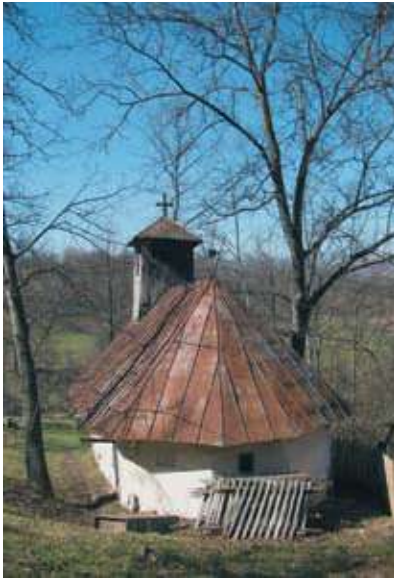
*Zinc metal roofing often placed over the degraded shingle roofing*

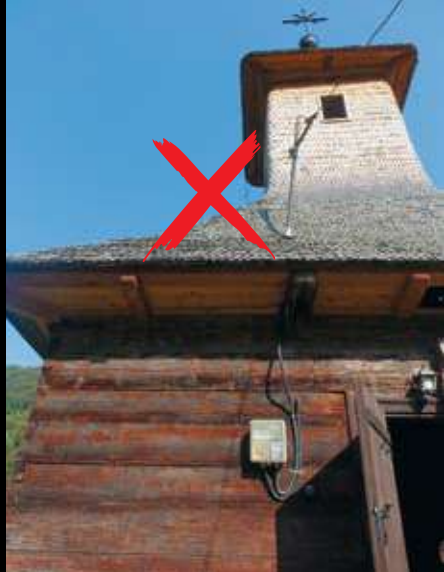
Example of external electrical connection that is not fireproof.

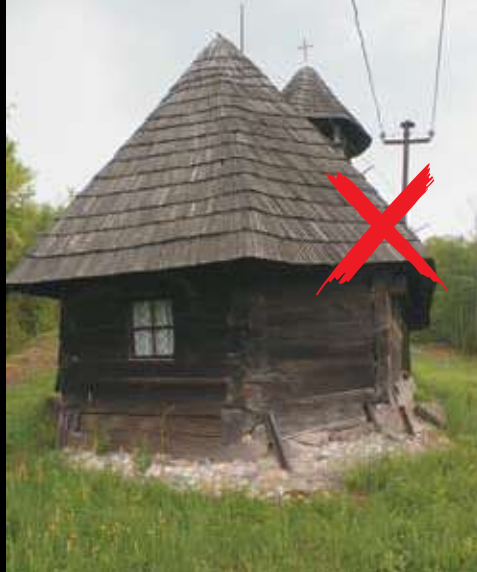
Example of common electrical connection through the roof where the shingles will deteriorate the fastest.

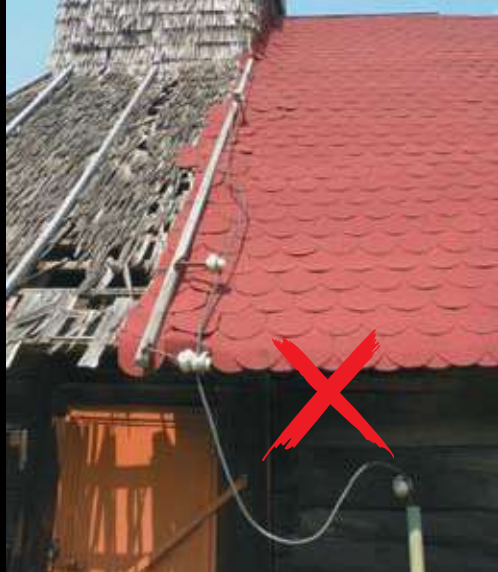
Example of lightning rod fixed on roofing in the process of replacing. Fixing spots are spots where the shingle deteriorates faster.

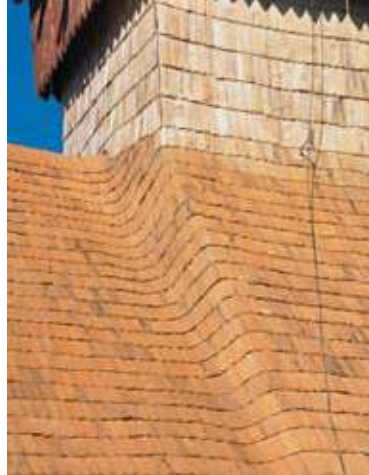
Lightning rod fixed on wooden shingle roofing; it is the most commonly-occurring system. Fixing spots should be insulated so that in case of overheating, it won't cause fire. Joining points on the shingles are usually vulnerable spots where the shingles deteriorate faster.

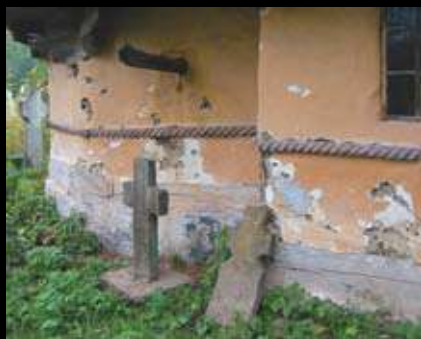
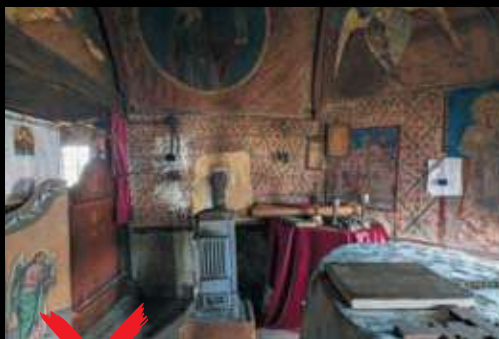
Examples of improvised heating systems. The stove horn pierces the wall and can cause a fire because it's not protected against overheating. It also damaged the painted decoration.

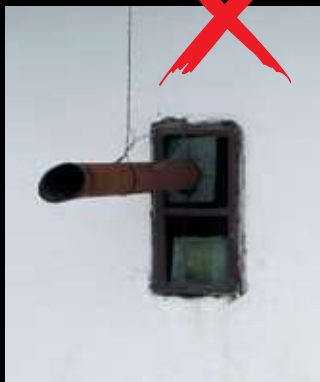
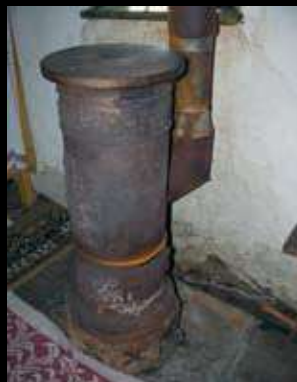
## *Heating Systems*

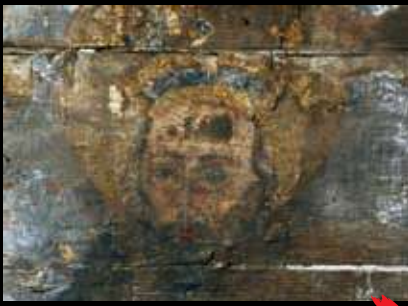
*Al secco* painting that is flaking from the wall because of persistent humidity.

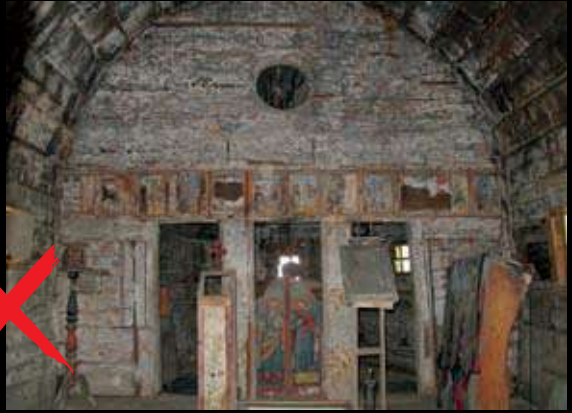
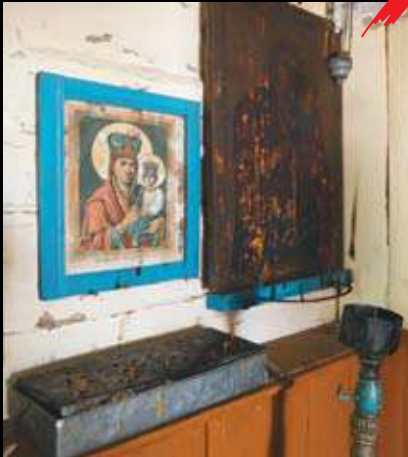
Candle stand placed under the icon and in the proximity of the wooden wall. Placement of candles can also cause a fire.

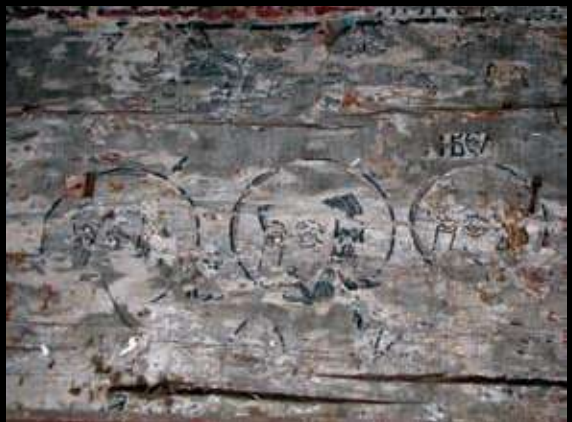
*Al secco* painting cleaned by scrubbing until the painted image almost completely disappeared.

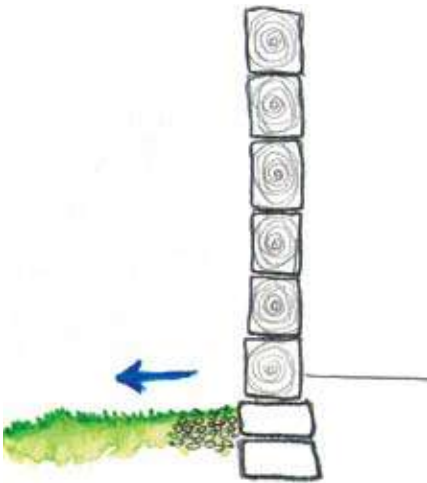
Correct drawing for design of the church surrounding area.

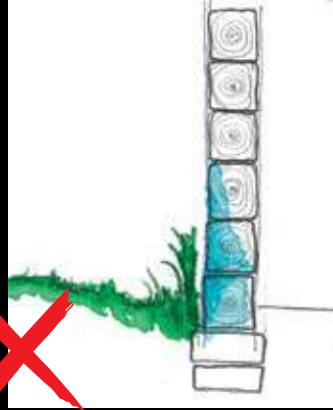
Overgrown vegetation and wrong gradient cause long-lasting humidity inside the wall leading to wood decay.

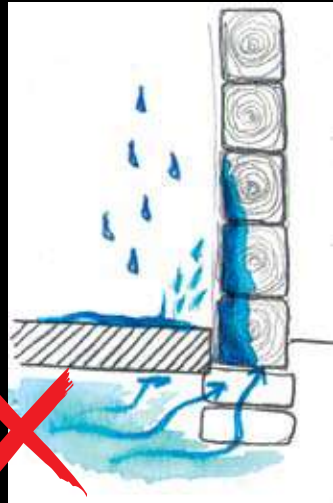
Designing a waterproof pathway (concrete, stone set on a cement layer or other similar systems) retains humidity in the earth around the wall. This way, the wall will deteriorate in time because of accumulating humidity stagnating in the wood.

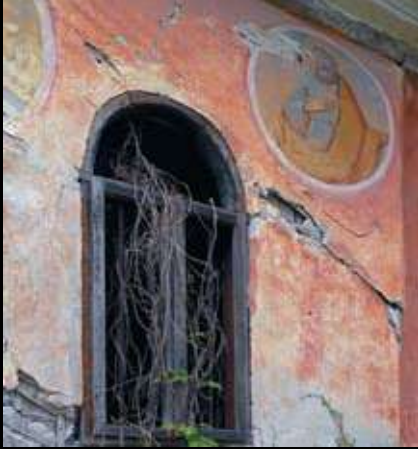
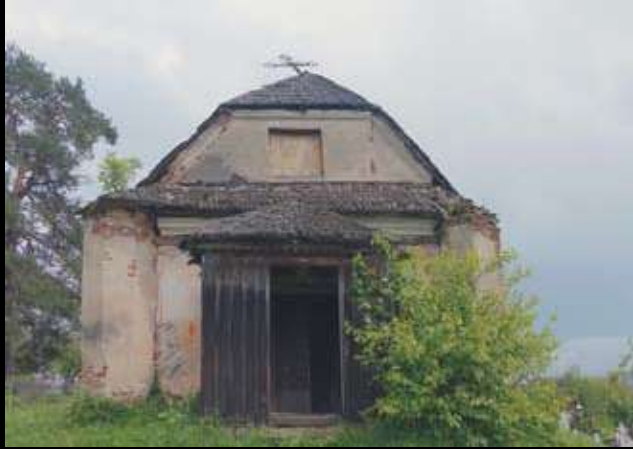
Growing vegetation covers churches that are not used and not maintained.

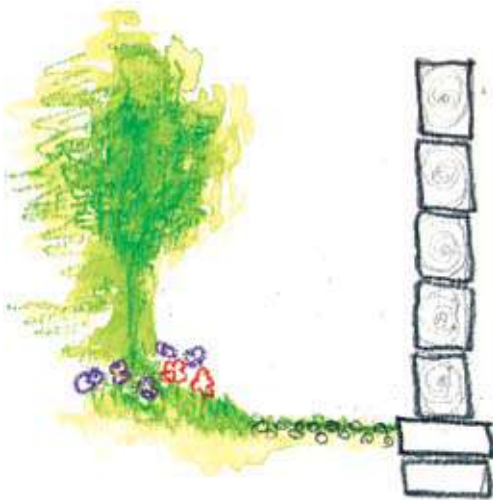
Drawing for exterior design of vegetation around the church. It is recommended that tall vegetation (trees, bushes) be placed far from the church wall and the surrounding pathway have an outer drainage gradient.

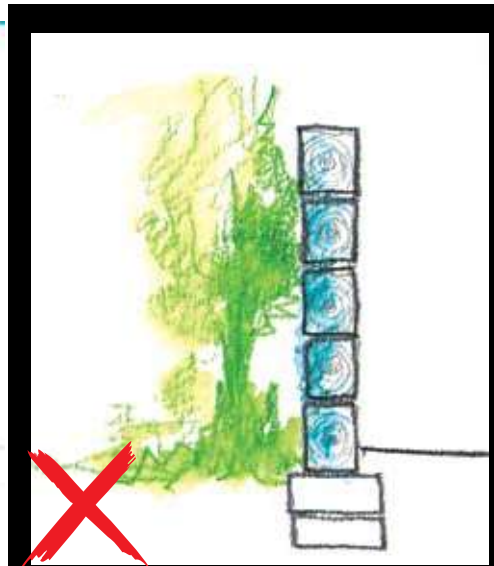
Grown vegetation that is too close retains humidity in the building, roots grown under the foundations cause displacement of the building and cracks, and vines damage the painting.

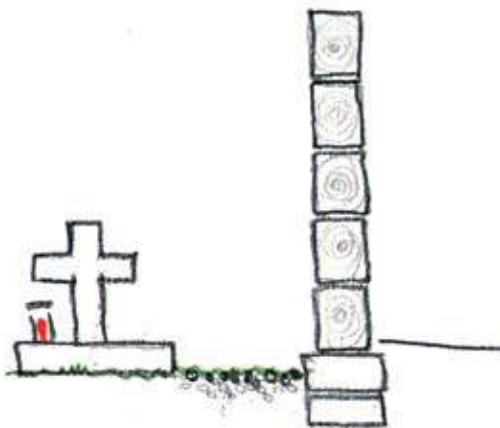
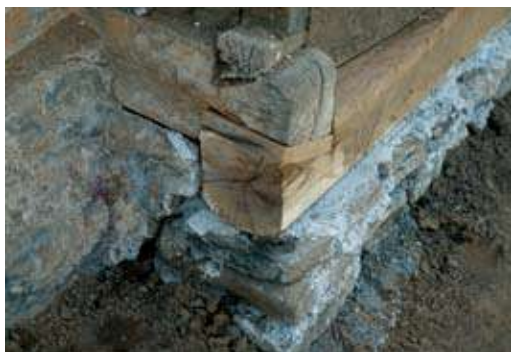
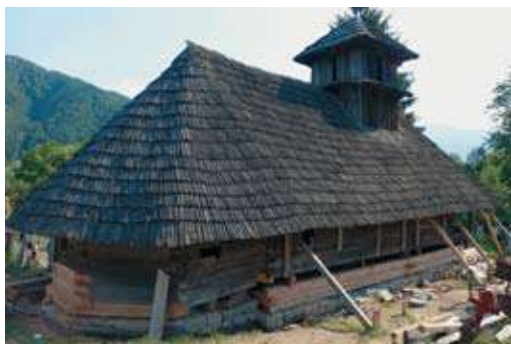
Example of replacement of deteriorated bottom logs with new logs set on stone base.

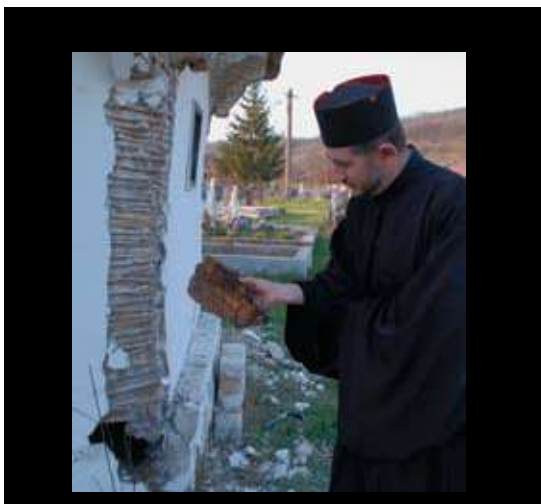
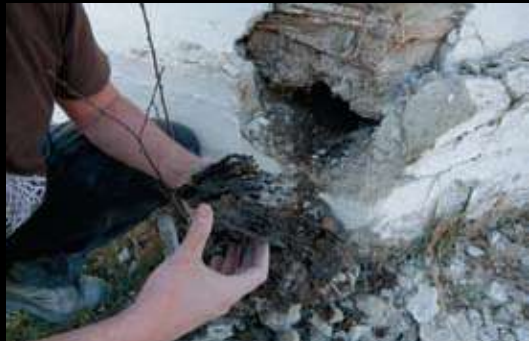
This is what wood dressed in cement on the exterior looks like.

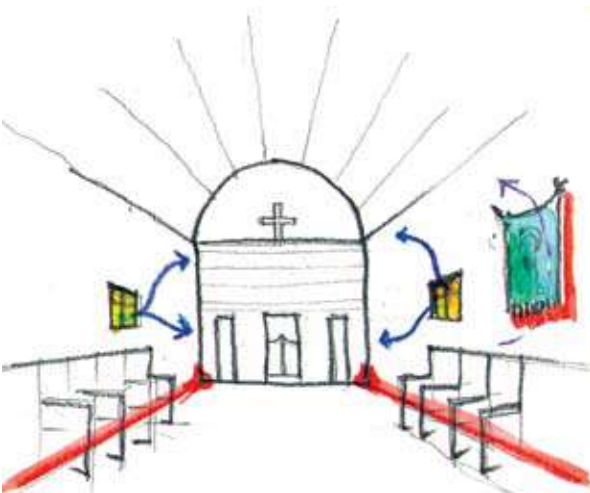
Airing and good ventilation is needed inside the church. Behind hung elements on the wall or at the bonding between wall and floor mould or humidity spots can appear because these are areas less aired. They should be checked regularly and cleaned.

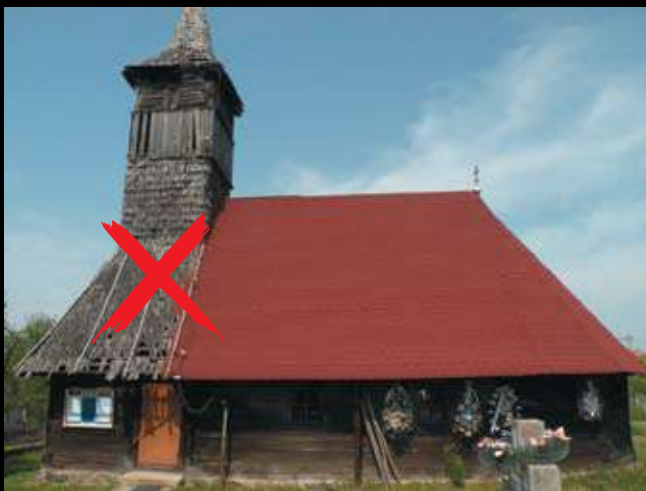
### *Roofing Repairs*

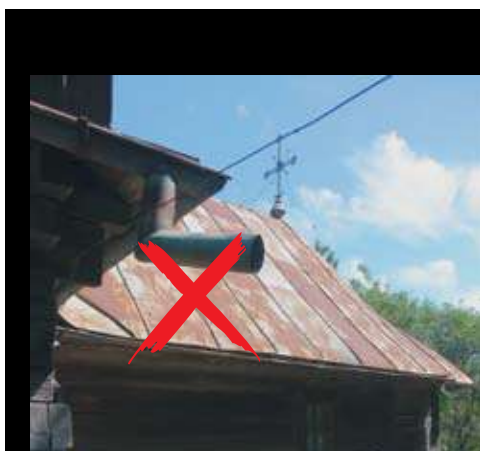
Example of water collection through gutters and downspouts. These must be checked regularly, leaned and even repaired. Otherwise, they cause much more and faster damage than the free rainwater flow. In winter, icicles appear and can cause injuries if not removed.

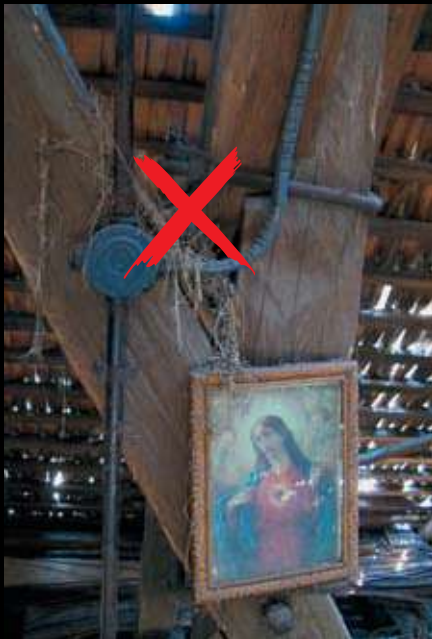
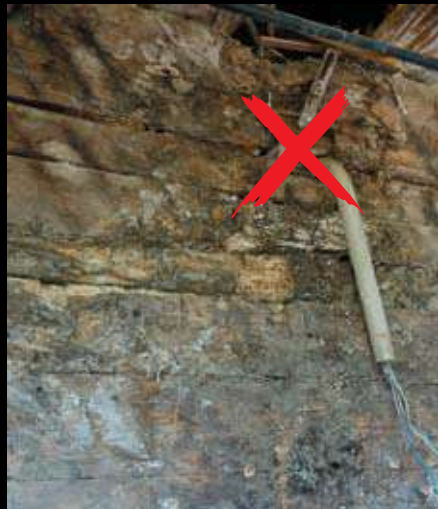
Examples of improvised electrical connections that can cause damages and can affect the church image.

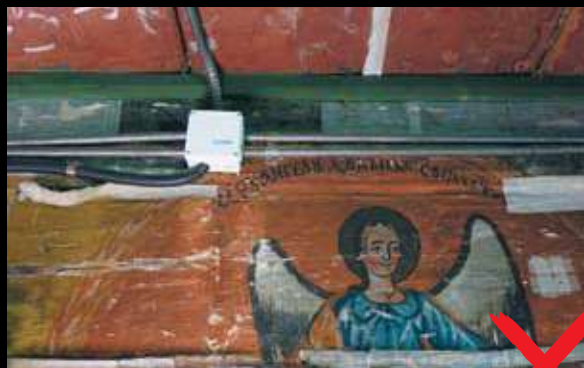
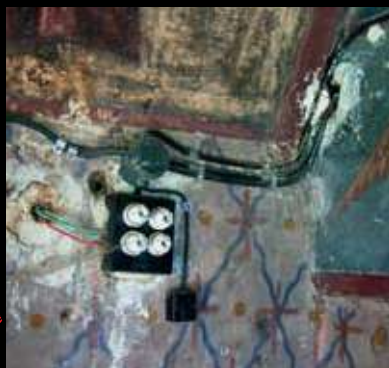
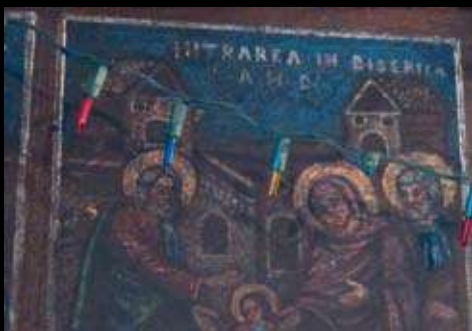
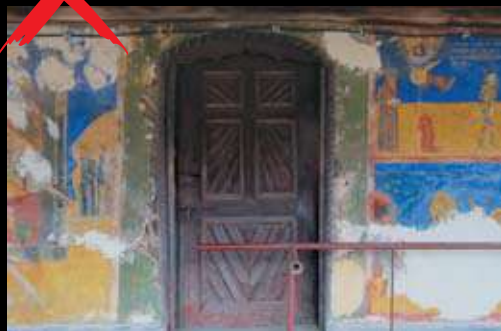
Examples of improvised electrical wiring placed over the painted decoration.

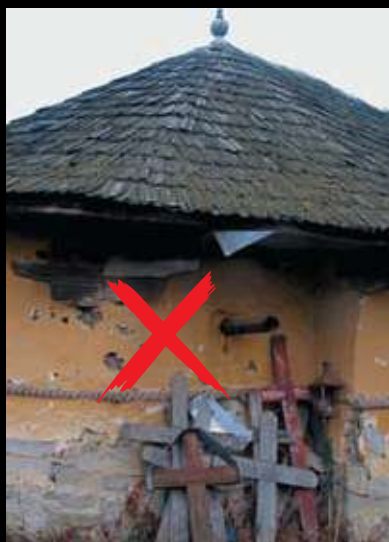
Improper stove chimney piercing the wall.

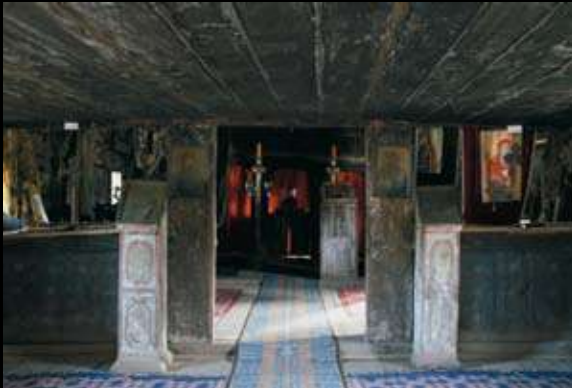
Example of painting darkened by dust and smoke.

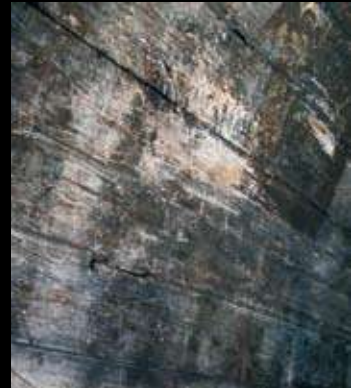
Example of painting scraped by possible attempt at cleaning or vandalism.

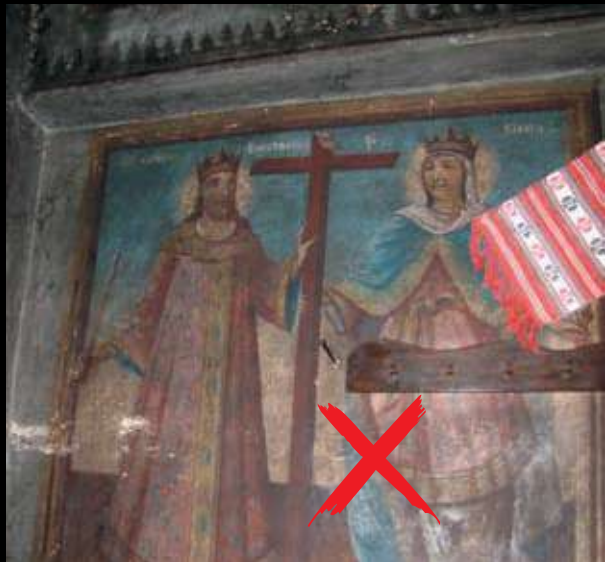
**Erosion and flaking of painting** caused by repeated touch appear from improper use. During services, parishioners rest against the walls or deposit objects or clothing against the painting. Periodic friction causes the colour pigment to erode and flake off. In the case of churches where painting conservation is in a risky state and the painting is flaking off the wall, touching the surface can lead to severe displacements and irreversible losses.

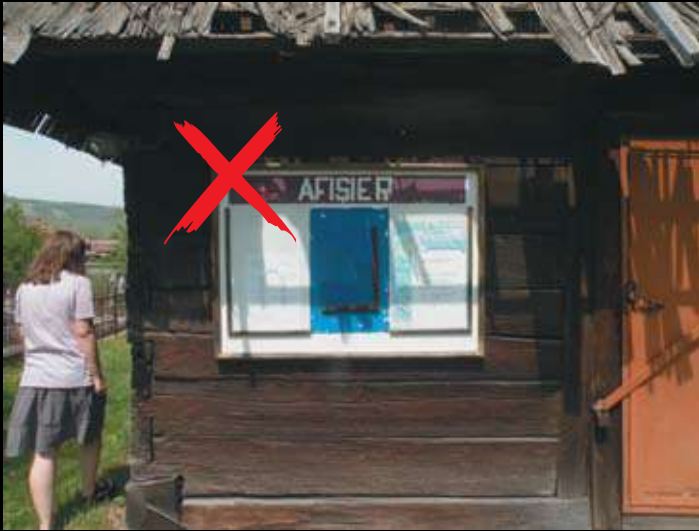
Object unsuitable with the image and specific of the church, placed on an outer wall.

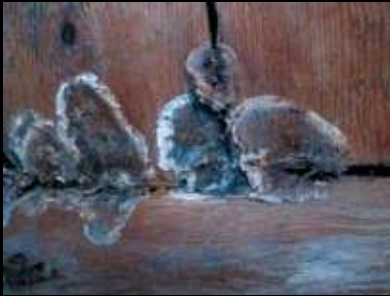
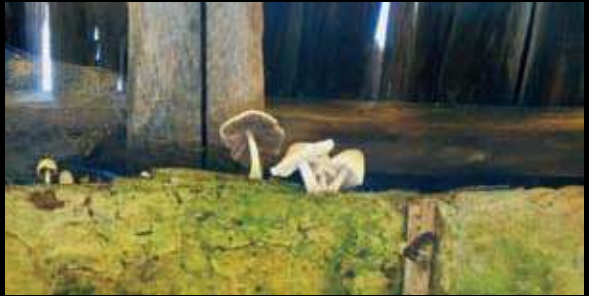
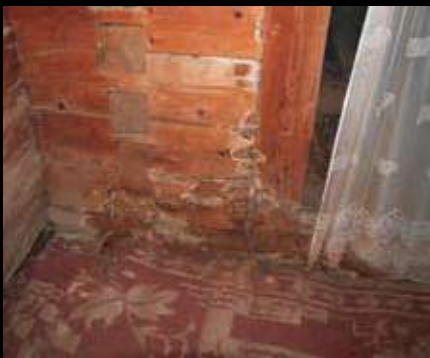
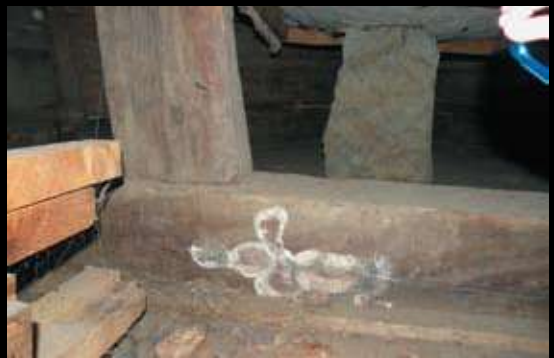
Biological wood decay in areas with increased humidity levels (fungi causing decay).

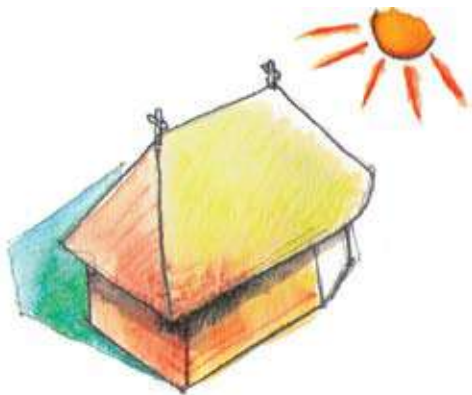
The sunny sides of the church (east, south and west) don't have significant humidity problems, but there are great variations in temperature on the wooden surface that cause contractions and cracks. These don't weaken the wood durability unless a biological attack sets in (insects or fungi).

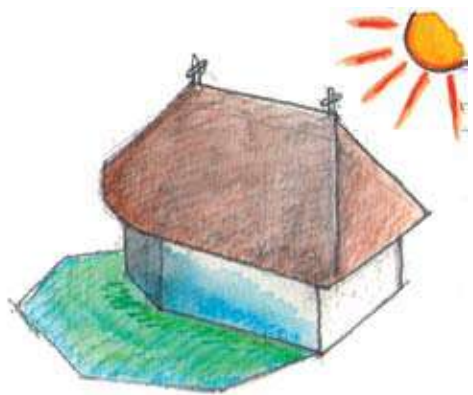
The north side is shaded, so there are greater chances that the walls present persistent humidity. For prevention, ventilation and removal of overgrown vegetation are important.

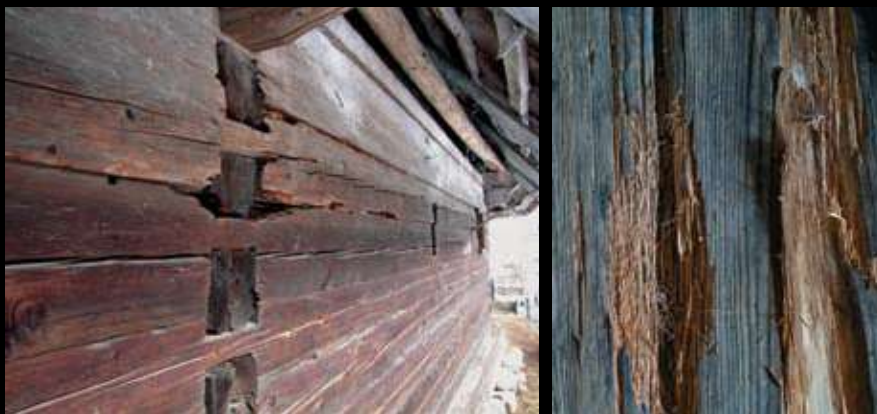
Softwood (resinous wood) is more sensitive to insect attack.

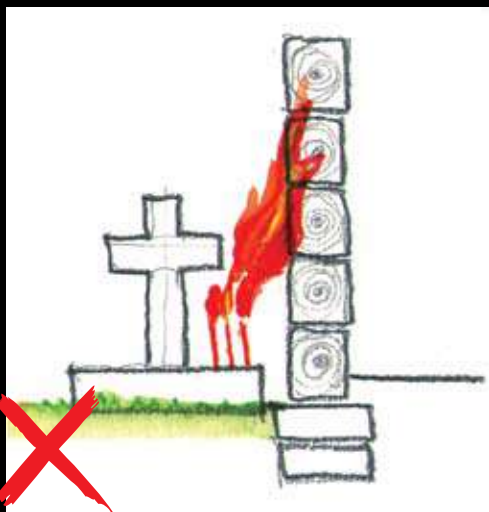
Lit candles can cause the graves too close to the church wall to catch fire. Also, the graves obstruct perimeter circulation and proper rainwater drainage.

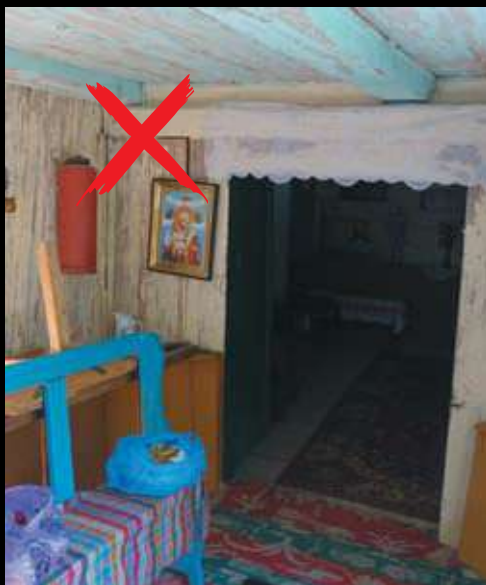
A fire extinguisher is recommended in the church but his presence should be as unobtrusive as possible.

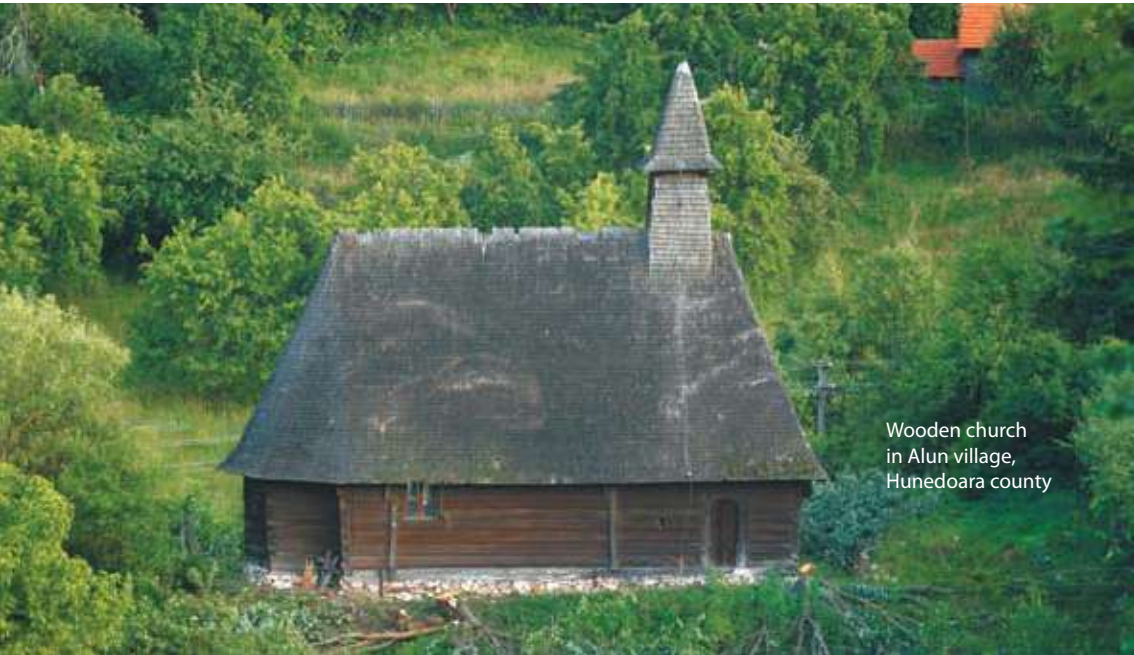
Wooden church  
in Alun village,  
Hunedoara county

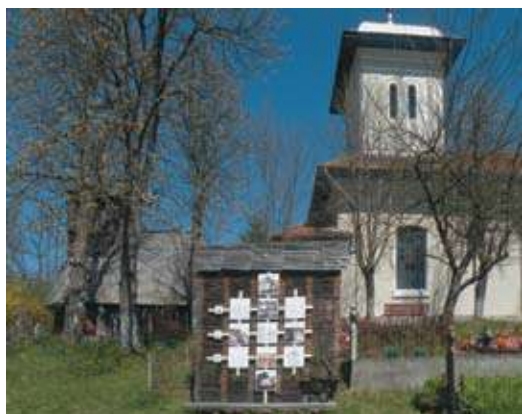
Information panel made in 2012 by the volunteer students who supervised the roofing repair works.

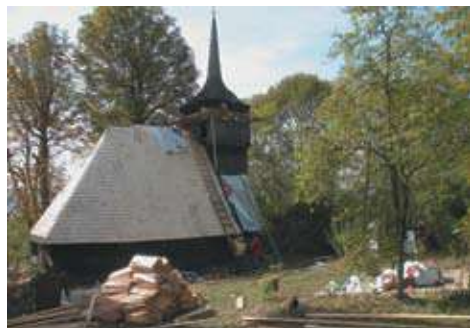
Image from shingle replacement process.

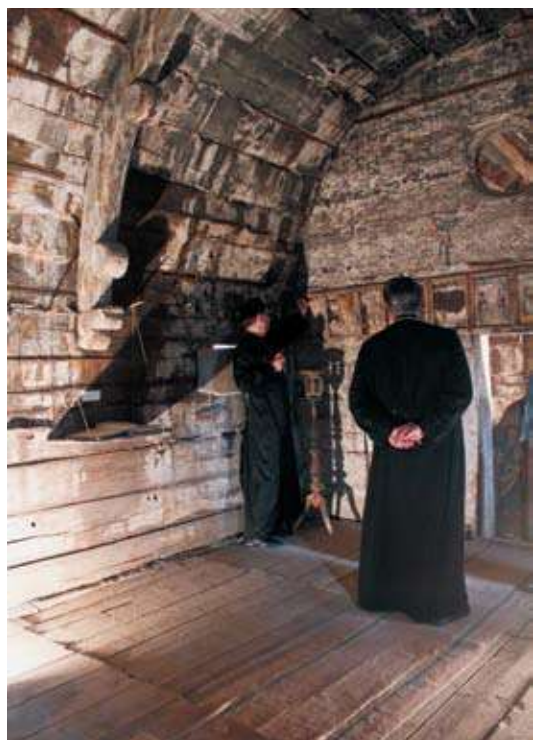
Exhibition created by volunteer students in 2012 with objects found in the church and objects donated by the community.

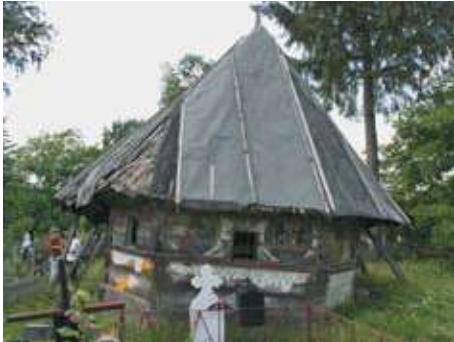
The church in 2009 before the collapse of the vault.

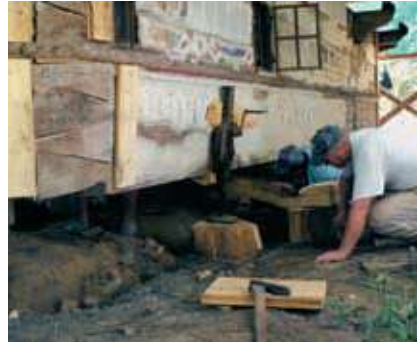
Elevation of the church to replace bottom logs and build a stone foundation in 2013.

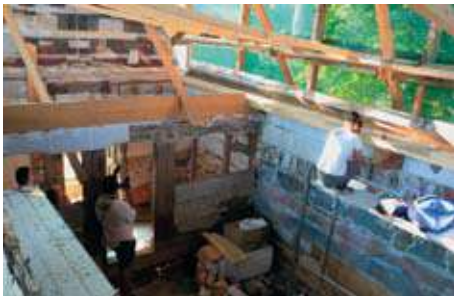
Reassembly of wooden vault in 2015.
