Cover I : wooden church in Boz village  
Cover II : wooden church in Târnavița village;  
interior of the wooden church in Crivina de Sus village

Raluca Munteanu

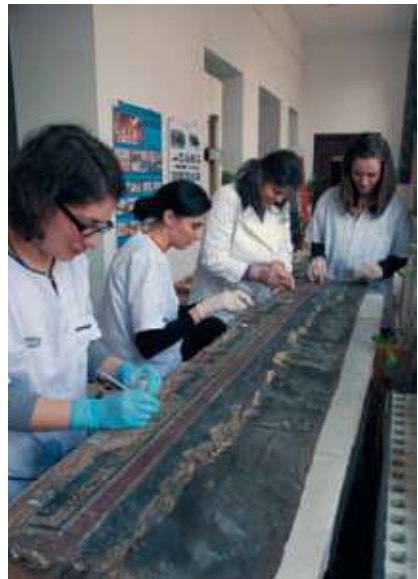
Vault painting restoration at the National University of Art in Bucharest, 2012-2015.

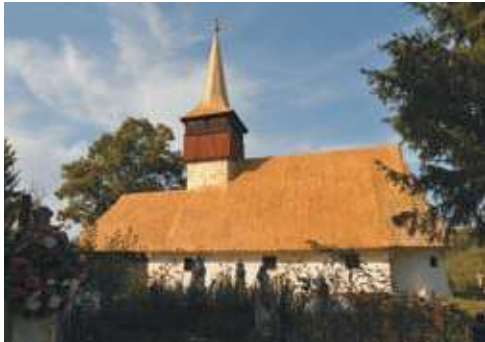
Church after shingle replacement in 2012.

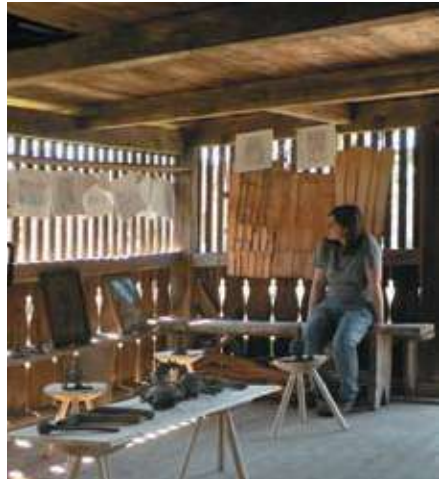
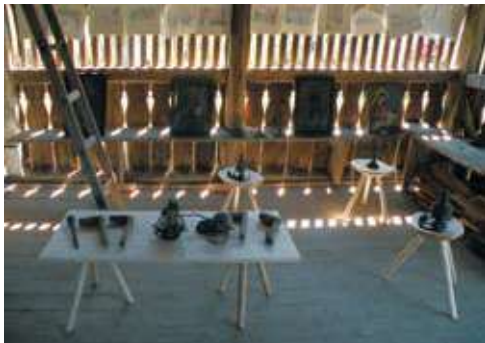
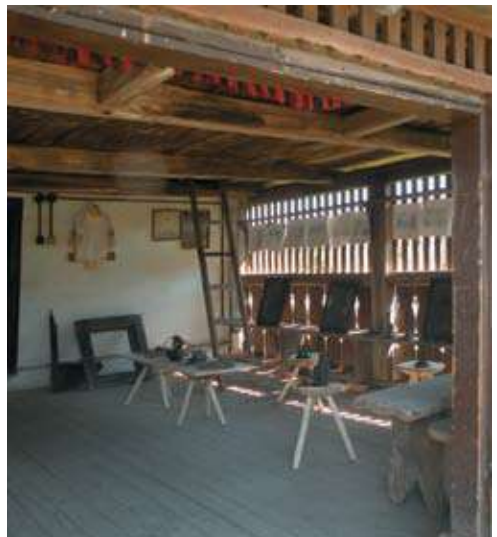
Exhibition designed by volunteer students in 2012 with objects found in the church and objects donated by the community.

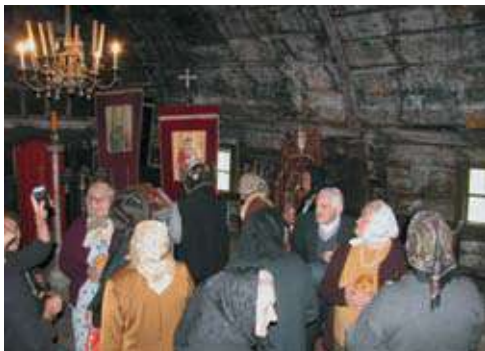
The wooden church in **Pojogeni** village (1797), Gorj county, is a special case because it was found in a state of near collapse and saved by dismantling and reassembly at Cămărășeasca Monastery (1780) in Târgul Cărbunari which is 10 km away.

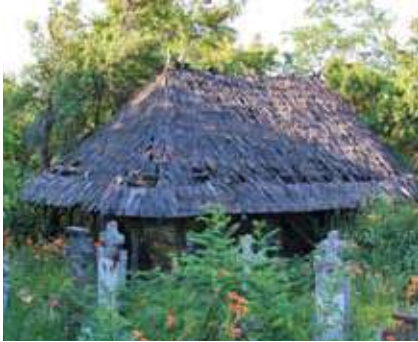
The wooden church quickly became part of the monastic life and of the neighbouring community; it is now properly used and taken care of.

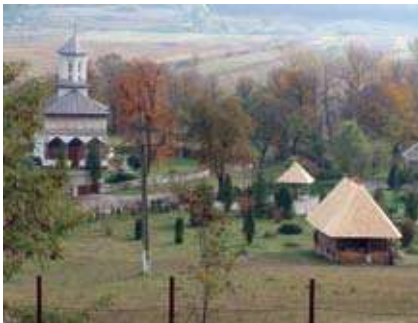
In 2012 the program *60 wooden churches* included an intervention on a wooden church in Botoșani at the request of the parish priest and the founder's family who wanted to bring to light the small church in **Cervicești** (1861). Repairs were supervised by Pro Patrimonio volunteers who, through small interventions, caught the villagers' interest for the old church. Even when the repair works were in progress, a demand for a wedding service in the wooden church was forwarded.

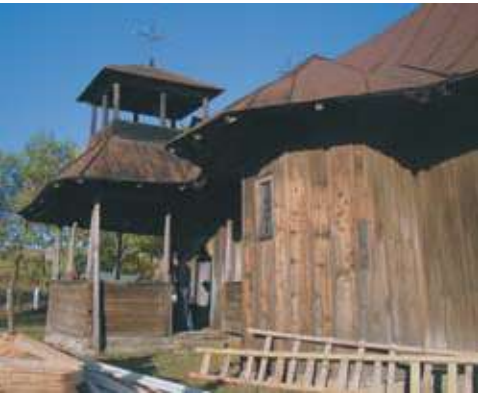
The church before repairs.

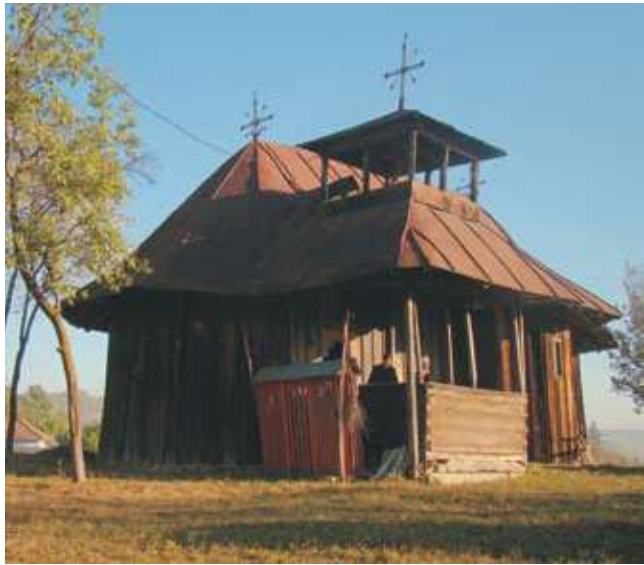
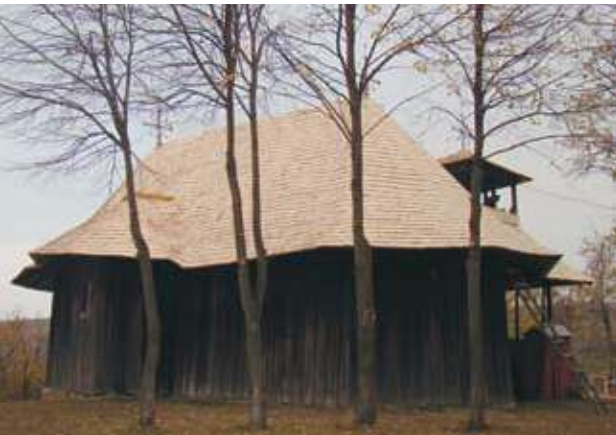
The church after repairs and replacement of zinc steel roofing with wooden shingles.

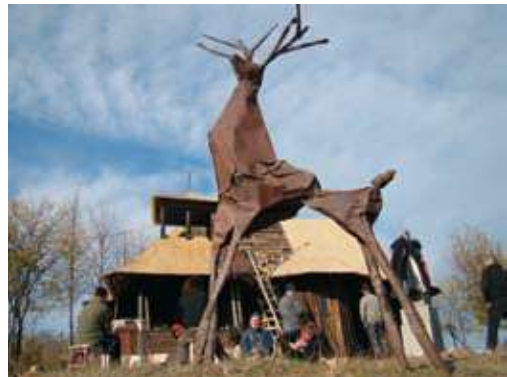
A stag made from the removed zinc roofing sheets. The stag is the symbol of the village and at the origin of its name.
